## Supplemental Report

Bryson v. Rough Country, LLC

Mecanica Case Number: 22-3104

Date of Collision: March 15, 2020

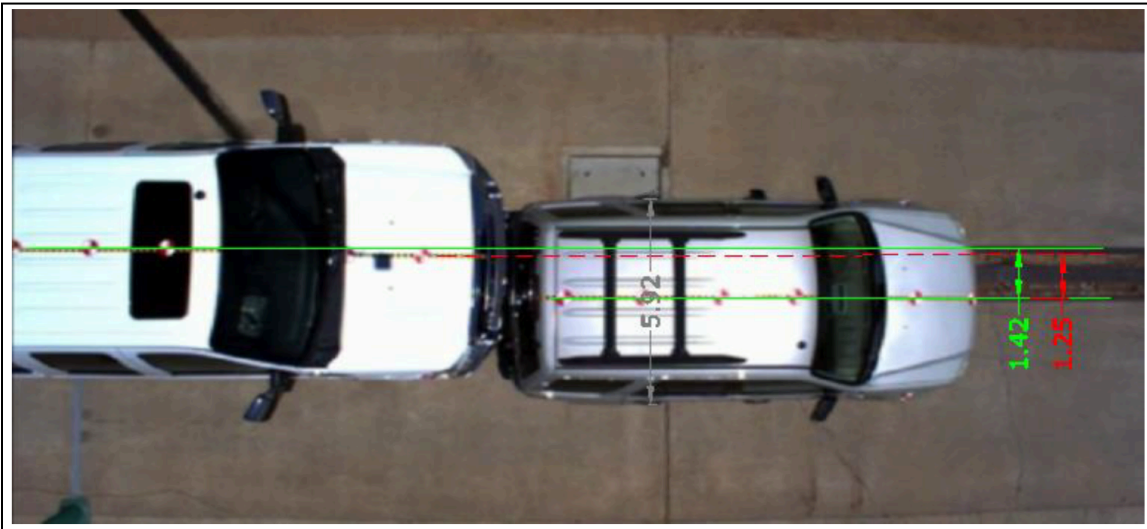
Mr. Buchner on page 8 and page 9 of his June 14, 2024, report used a frame from the crash test overhead video (QE Figure 6) to measure the difference between the longitudinal centerlines or offset of the crash test vehicles (**Figure 47**). As can be seen in the QE Figure 6, the overhead camera was not centered over the crash rail, but more centered over the Escape. Furthermore, the still frame used in the QE report was not at impact. T0 (time zero) lights were placed on the F-250. These lights illuminate when the vehicle first contact, indicating impact, and were not illuminated in Figure 6 of the QE report.

**Figure 6:** Scaled image from crash test video with the total offset measurements

**Figure 47:** Figure 6 from QE report dated 6/14/24. Camera not centered over crash rail. (Still frame rotated 180 degrees.)

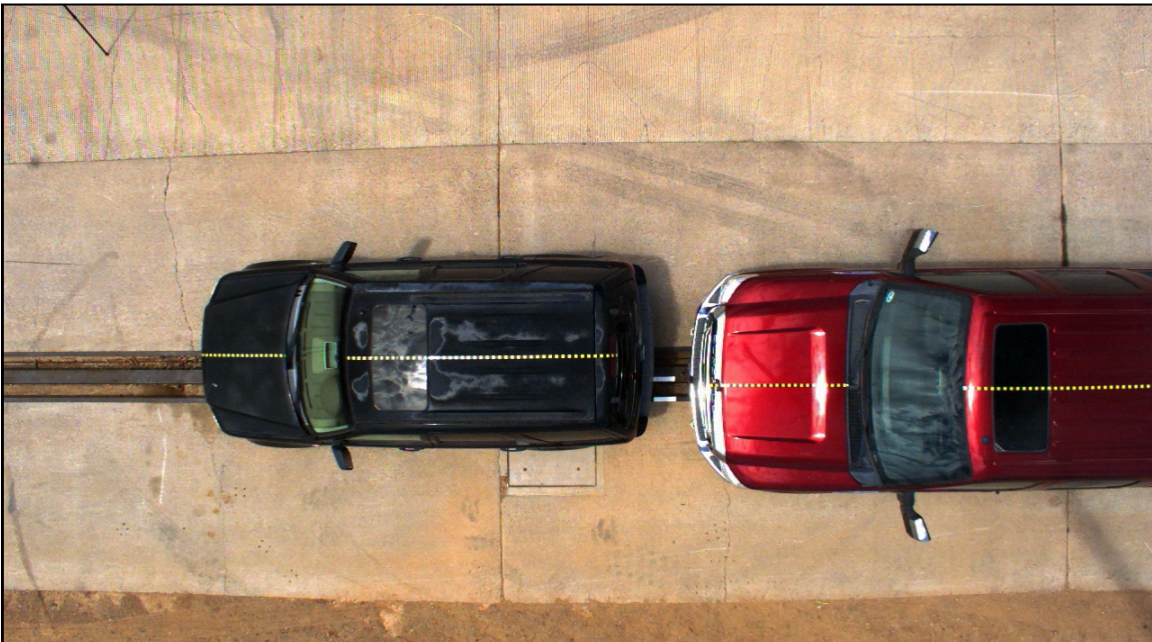
Mecanica performed the test setup again with exemplar vehicles on June 25, 2024, at Exponent with the overhead camera in a similar position to the crash test (**Figure 48** and **Figure 49**). With the overhead camera in a similar position, it can be seen that even though the F250's longitudinal centerline is over the center of the crash rail, it appears that it is to the left of the rail three inches or more (**Figure 50**). This is due to the parallax of the camera. This can also be observed at the bottom of the overhead camera photograph where the concrete edge appears curved.

**Figure 48:** Overhead video camera view with the exemplar F-250 centerline over the crash rail centerline.

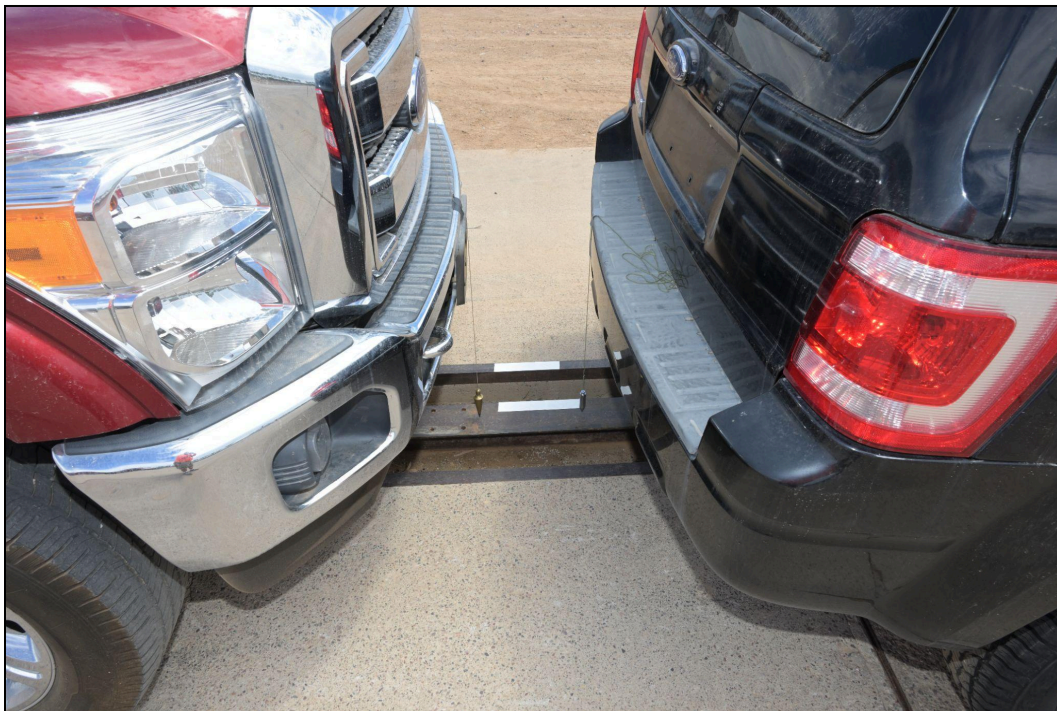
**Figure 50: Vehicles in the same position as Figure Z above.**

As seen from the overhead video camera from the crash test, the inch tape on the F-250 hood is aligned approximately one-half to one inch inside the left rear-window hinge of the Escape (**Figure 51**). The illuminated T0 lights on the dash and left A-pillar show this frame was at time

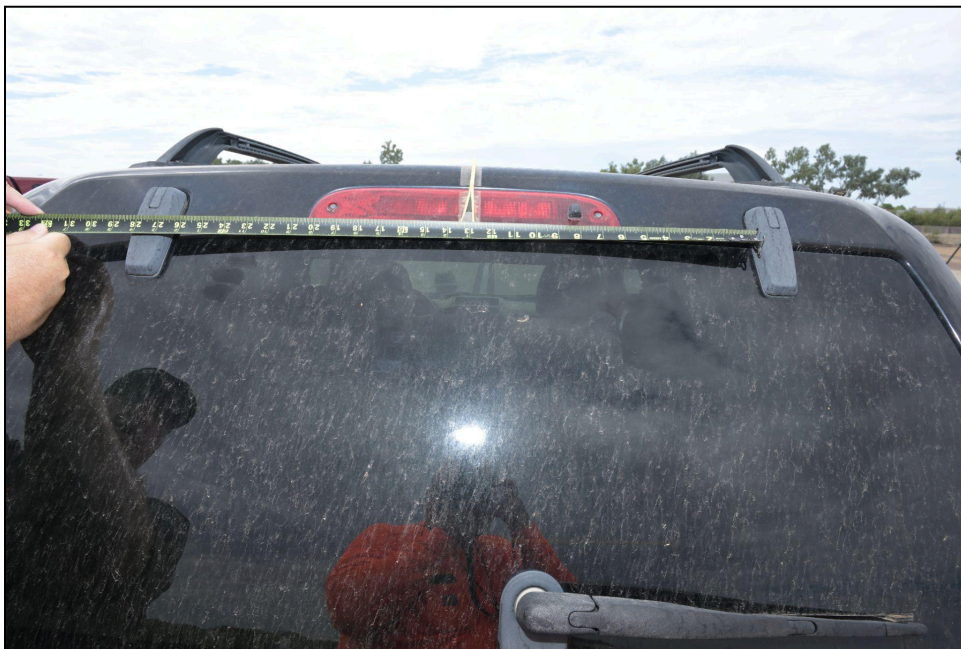
zero (T0) or impact. Since these two locations are relatively close in height, camera parallax is decreased. The distance between the Escape rear-window hinges was approximately 26.5 inches (**Figure 52**), so the distance between the inside of the left hinge and the Escape's longitudinal centerline was 13.25 inches. Removing one inch to one-and-one-half inches from that distance indicates the F-250's longitudinal centerline was approximately 11.75 inches to 12.25 inches to the left of the Escape's longitudinal centerline.

**Figure 52: Distance between the rear window hinges.**

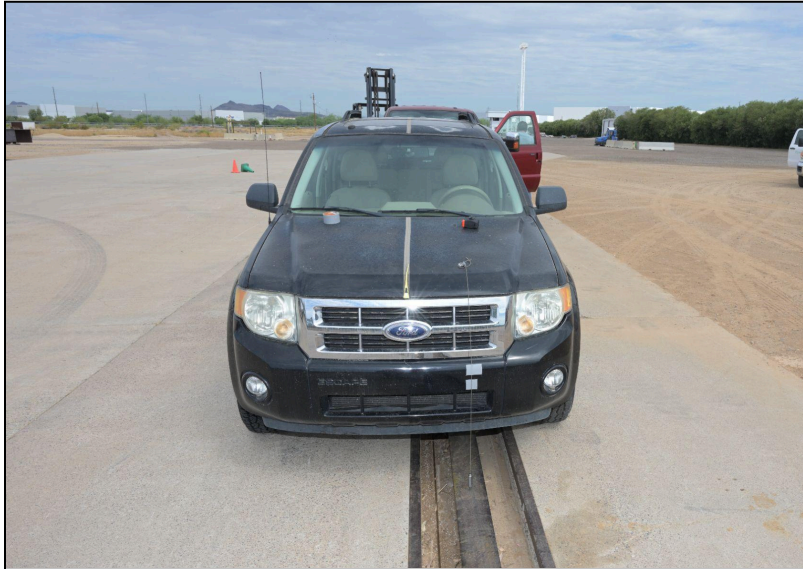
Exemplar vehicles were also lined up to replicate the crash test alignment. The Escape was first aligned on the crash rail. Measurements were taken from the longitudinal centerline of the Escape 10.9 inches to the left on the front and rear bumpers. These points were then aligned with the crash rail centerline (**Figures 53 and Figure 54**). The front of the F-250 was then moved to the rear of the Escape, with the F-250's longitudinal centerline aligned with the crash rail centerline (**Figure 55**). In this configuration, the F-250's longitudinal centerline was just inside the left rear-window hinge (**Figure 56**).

**Figure 53: Front of an exemplar Escape with the crash rail centerline 10.9 inches left of Escape's longitudinal centerline.**

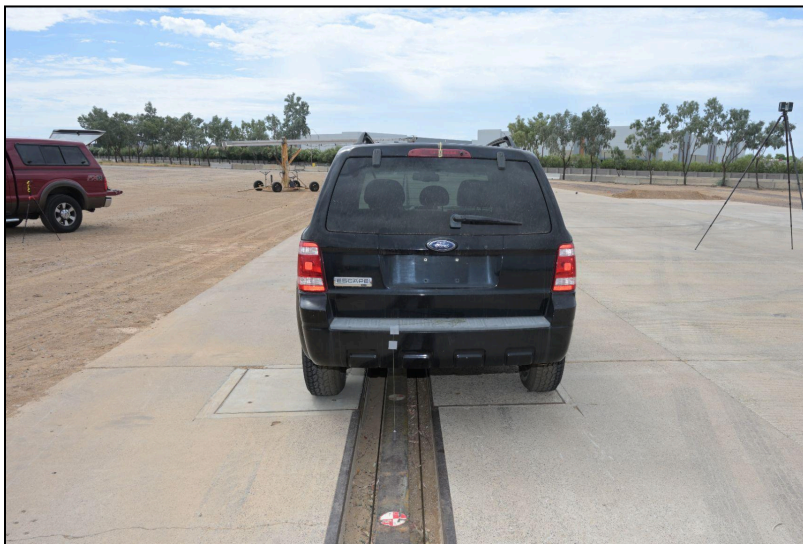
**Figure 54: Rear of an exemplar Escape with the crash rail centerline 10.9 inches left of Escape's longitudinal centerline.**

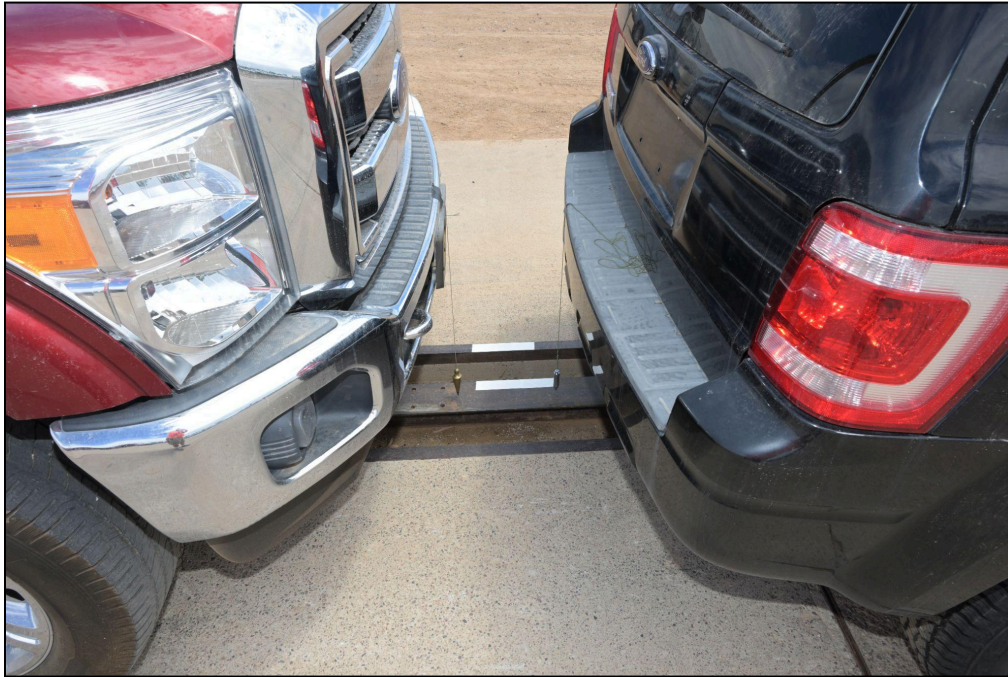
**Figure 55: Alignment of exemplar vehicles according to the crash test setup.**

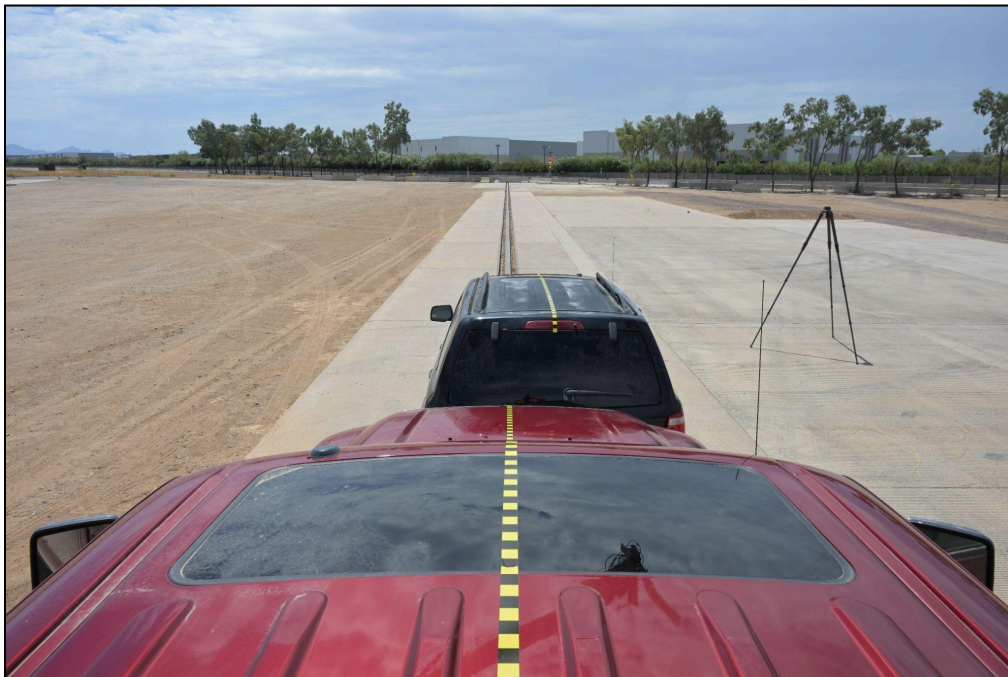
**Figure 56: Alignment of F-250's centerline with the Escape's left rear-window hinge.**

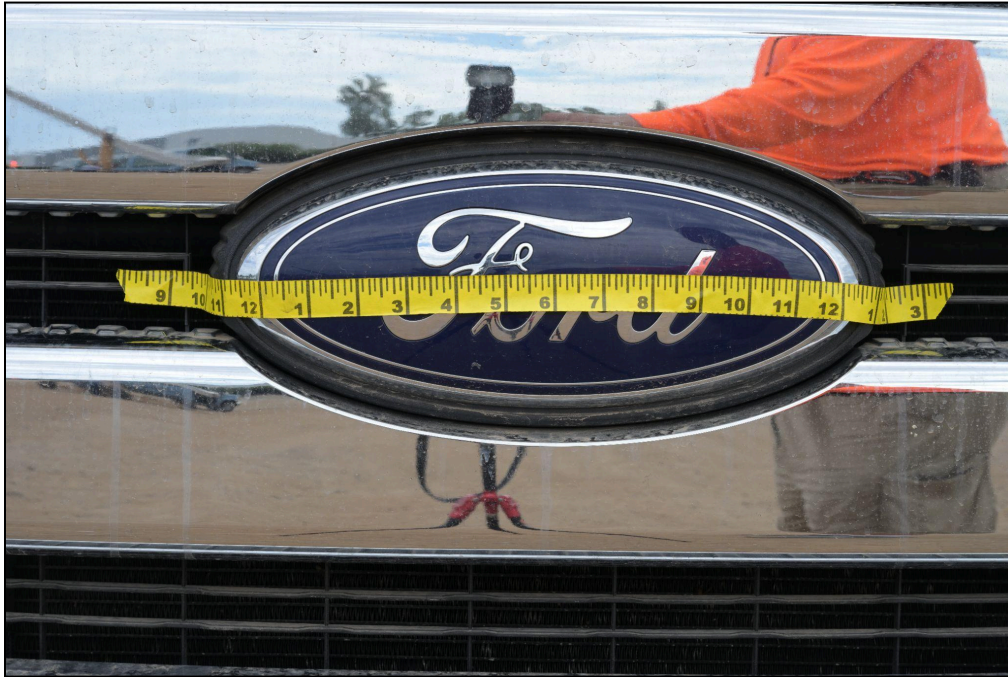
The Ford logo at the front of the F-250 was approximately 12 inches wide, from one outer edge of the blue border to the other, shown in **Figure 57**. The center of the logo was six inches from either outer edge of the blue border. In other words, the '6' on the inch tape is the approximate middle of the logo shown in **Figure 57**.

**Figure 57: Width of the Ford logo on the F-250**

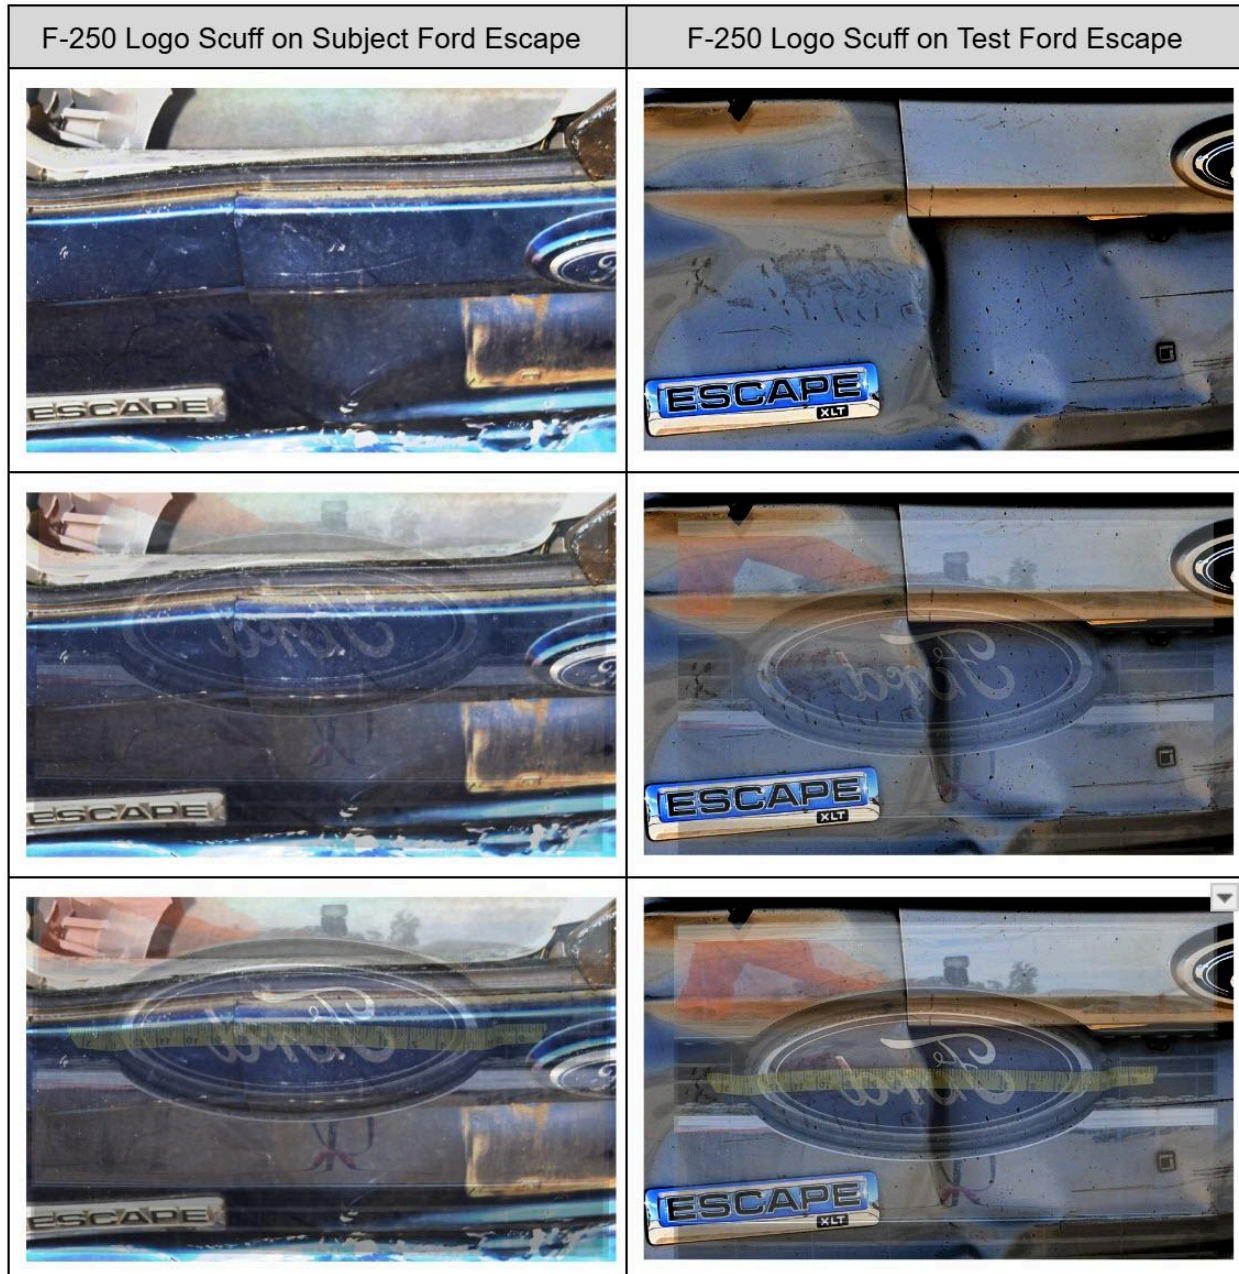
There were impressions, or scuffs, from a Ford F-250 logo on the Ford Escape from the subject crash as well as the Ford Escape used in the crash test. There was a trim panel on each Ford Escape located in the middle of the hatchback at the glass line, and the lower-left corner of this panel was used as a reference point on each vehicle to identify where the logo scuff was located.

There is no way to determine exactly when this logo impression was created during the interaction between the vehicles. They were not created at the initial point of impact since the F-250's front bumper would first contact the Escape. Also, note that these are complex 3-dimensional surfaces and 2-dimensional photos cannot place these marks more accurately than approximately a  $\frac{1}{4}$  (0.25) inch. **Figure 58** depicts photos from both vehicles and the progression of images including the following:

- The contrast was adjusted to increase the visibility of the logo scuffs.
- A mirror image of the exemplar Ford F-250 logo was overlaid.
- A mirror image of the Ford F-250 including inch tape was overlaid.

Figure 58: Image overlays depicting F-250 logo scuff on Ford Escape.

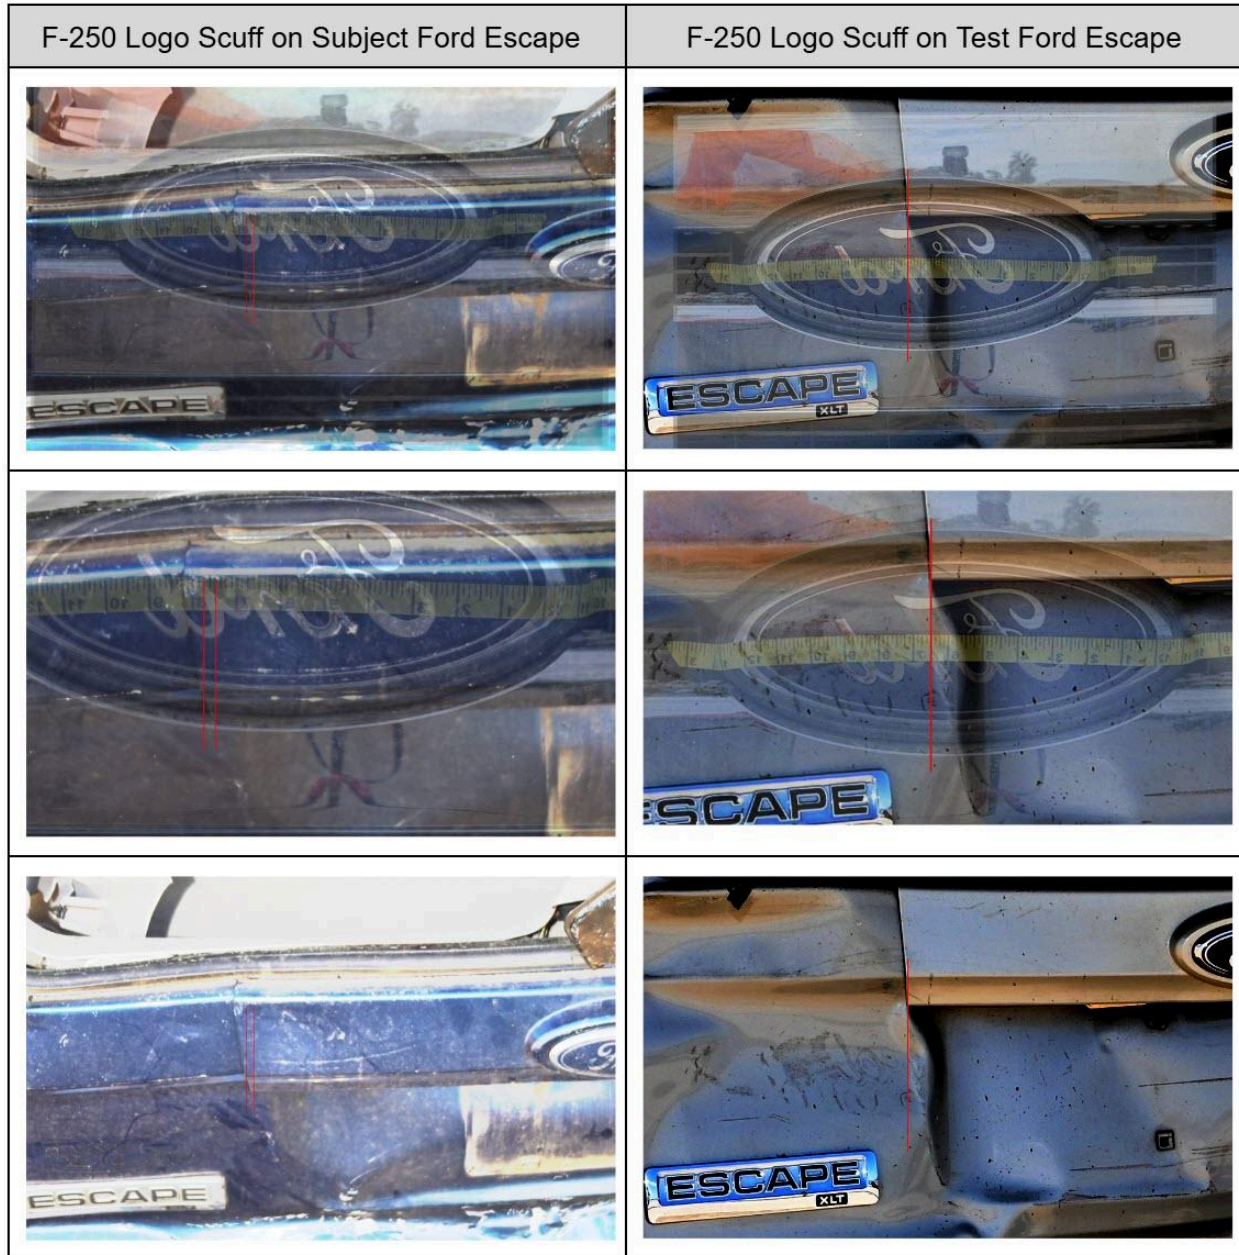
**Figure 59** continues the progression of images from **Figure 58**, including the following:

- Red 'index' lines were placed on the images referencing the lower left corner of the trim panel.
- A close-up of the image with the red index lines.
- The mirror image of the Ford F-250 logo was removed, leaving the red index lines.

**Figure 59:** Image overlays depicting F-250 logo scuff on Ford Escape with index marks.

On the subject crash Ford Escape, the middle of the logo impression was made on the trim piece below the rear window. The left column of **Figure 59** shows the center of the F-250 logo overlay located between 1.5 to 1.75 inches toward the right of the reference point on the subject crash vehicle.

On the crash test Ford Escape, the middle of the logo impression was slightly lower than the trim panel. The right column of **Figure 59** shows the center of the F-250 logo overlay located approximately 0.5 inches toward the right of the reference point.

Utilizing the analysis documented in these images it appears that the logo scuff on the crash test Ford Escape was approximately 1 inch to 1.25 inches farther left from the longitudinal centerline than was the logo scuff on the subject crash Ford Escape. A portion of this difference may be explained by the rear hatch displacement to the right as shown in the point clouds and photos.

16. Analysis of the F-250's front logo scuff on the rear of the Escape in the crash test indicates the centerline of the Ford was approximately 1 to 1.25 inches to the left of the logo scuff on the subject crash Ford Escape when the scuffs were made.

17. The location of the logo scuff on the test Escape was lower, relative to the hatch window, than the logo scuff on the subject crash Escape.
18. The F-250's front logo scuff on both Ford Escapes discussed are on complex 3-dimensional surfaces. These surfaces were distorted and displaced during the respective crashes and it is unknown exactly when the scuffs were made. In addition, some of the difference in logo scuff location might be explained by the rear hatch displacement to the right shown in scan files and photos.

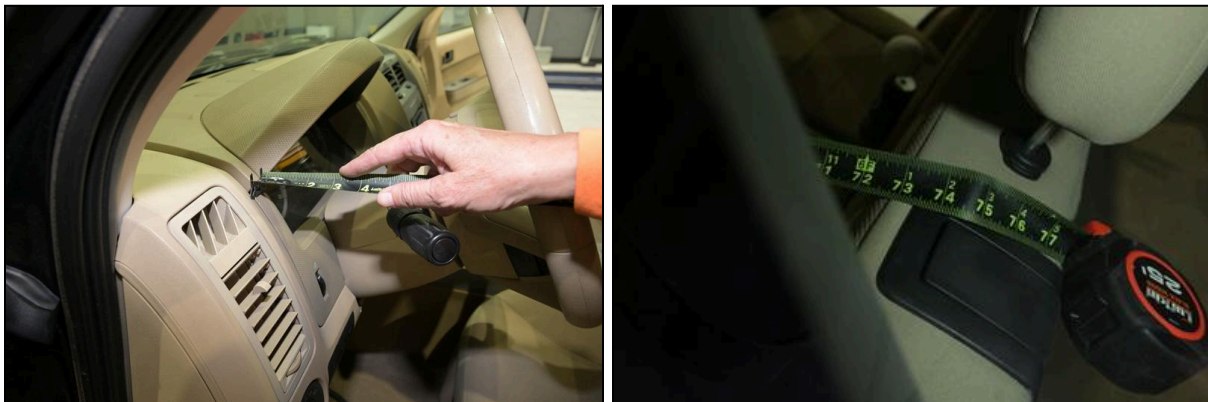
The interior of an exemplar Ford Escape was compared to the interior of the Ford Escape used in the crash test. The interiors were scanned and photographed. A measurement from a joint seam in the upper dash, just to the left of the instrument cluster, to the front edge of a black plastic trim panel just outboard of the left-rear headrest. This measurement was made in the exemplar vehicle and the test vehicle. **Figure 62** depicts this measurement in the exemplar Ford Escape. **Figure 63** depicts this measurement in the Ford Escape used in the crash test. This part of the rear seatback was displaced forward approximately 11.5 inches.

**Figure 62: Measurement to upper left of rear seatback in exemplar Ford Escape.**

21. The rear seat back was displaced forward in the test Escape. The top of the left-rear seat back was displaced forward approximately 11.5 inches and the top of the middle-rear seat back was displaced forward approximately 10 inches.
22. The Ford Escape's rear hatch made contact with the rear seat back in the crash test.
23. The ballasting of the crash test vehicles was typical for this type of test. The vehicles were ballasted to the approximate calculated axle weights.

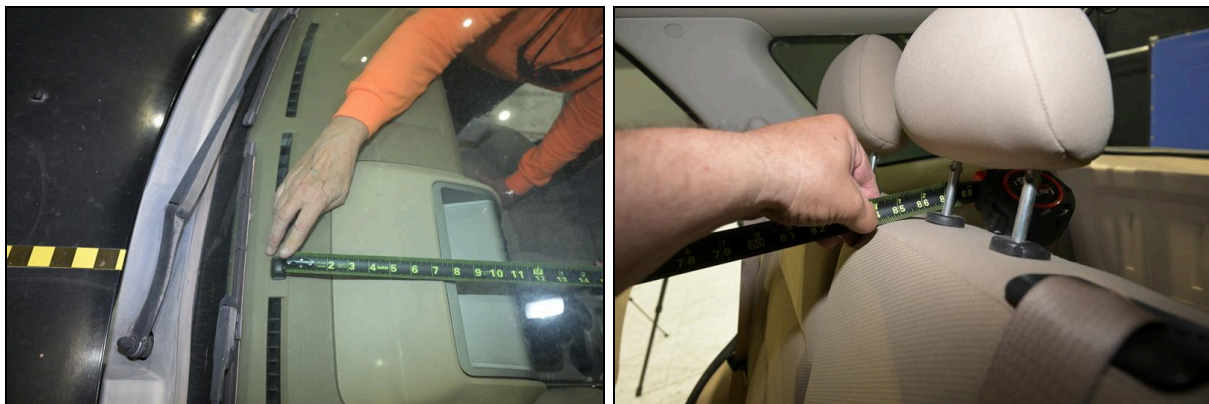
A measurement was made from the daylight sensor, located in the top middle of the dash, to the middle top of the rear seatback. The reference point on the rear seatback was a black plastic trim around the right headrest post. **Figure 64** depicts this measurement in the exemplar vehicle and **Figure 65** depicts this measurement in the test Ford Escape. This part of the rear seatback was displaced forward approximately 10 inches.

**Figure 64: Measurement to upper middle of rear seatback in exemplar Ford Escape.**

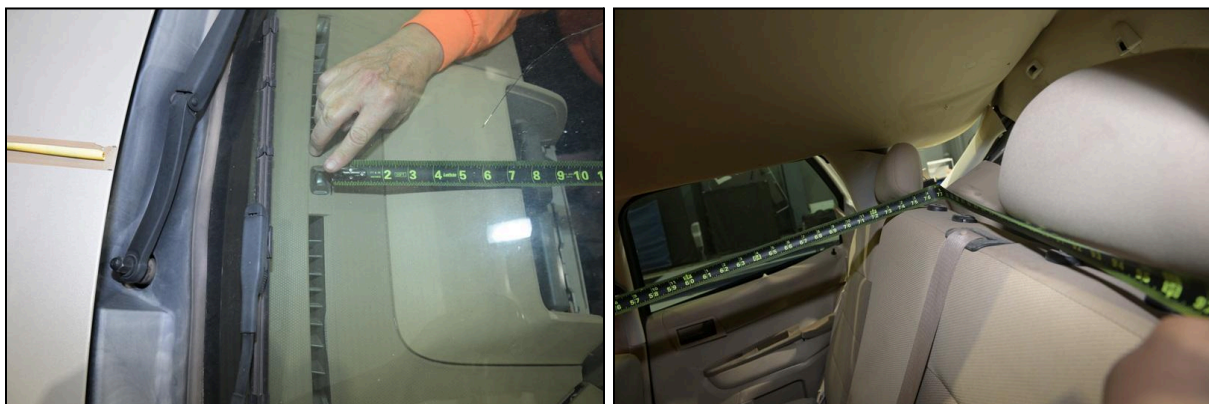
**Figure 65: Measurement to upper middle of rear seatback in test Ford Escape.**

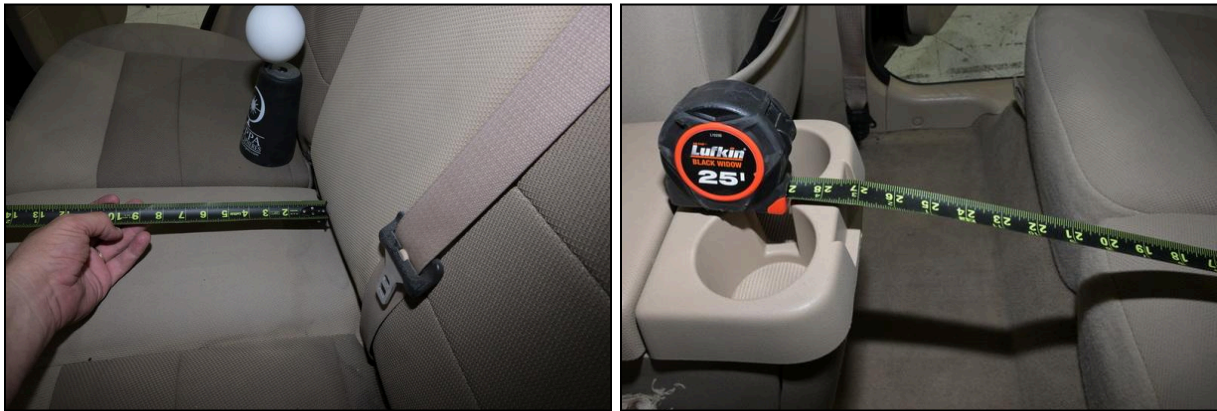
A measurement was made from the aft edge of the center console to the lower middle of the rear seatback. **Figure 66** depicts this measurement in the exemplar Ford Escape and **Figure 67** depicts this measurement in the test vehicle. This part of the rear seatback was displaced forward approximately 10.5 inches. Note that this measurement also includes more of a vertical component in the exemplar vehicle, thus the actual displacement would be slightly less.

**Figure 66:- Measurement to lower middle of rear seatback in exemplar Ford Escape.**

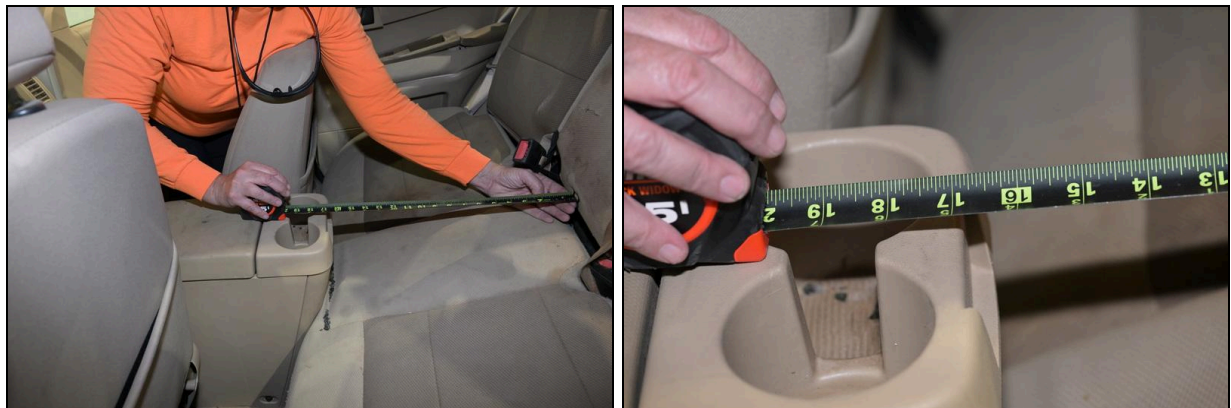
**Figure 67: Measurement to lower middle of rear seatback in test Ford Escape.**

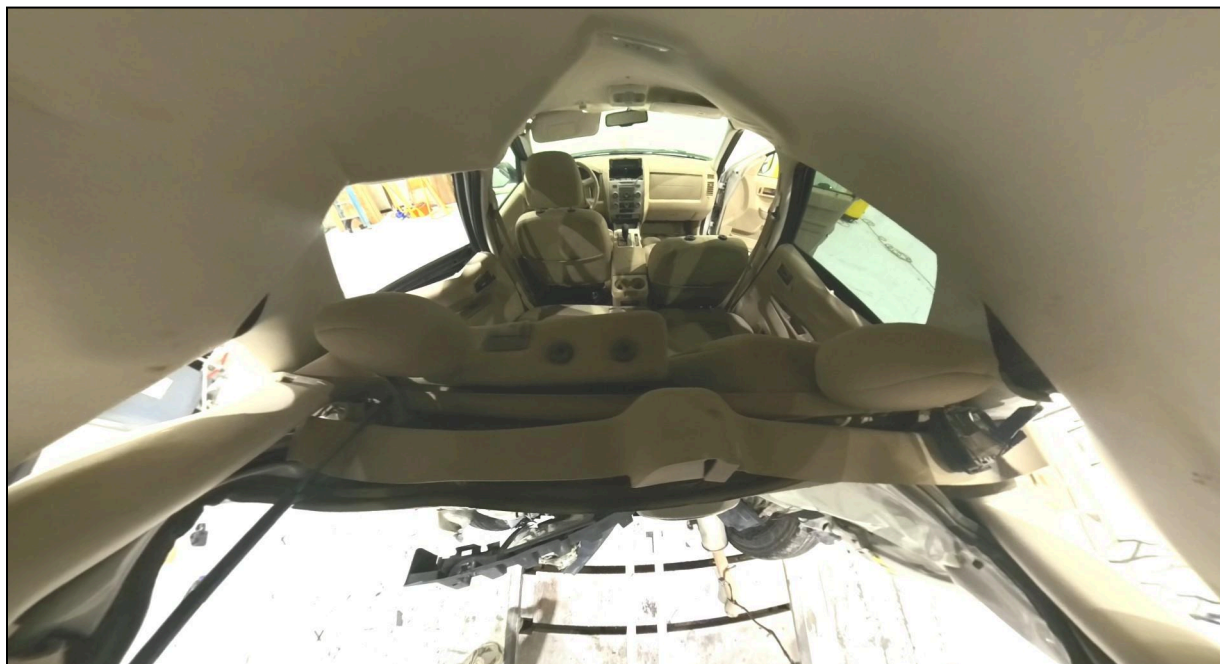
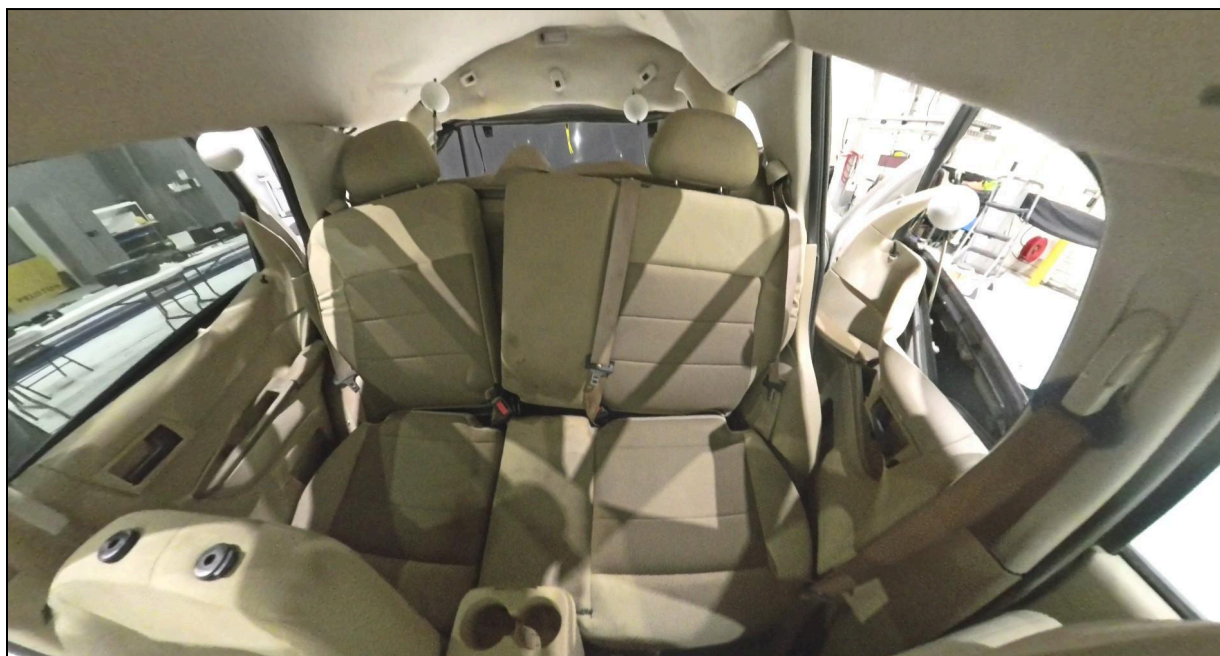
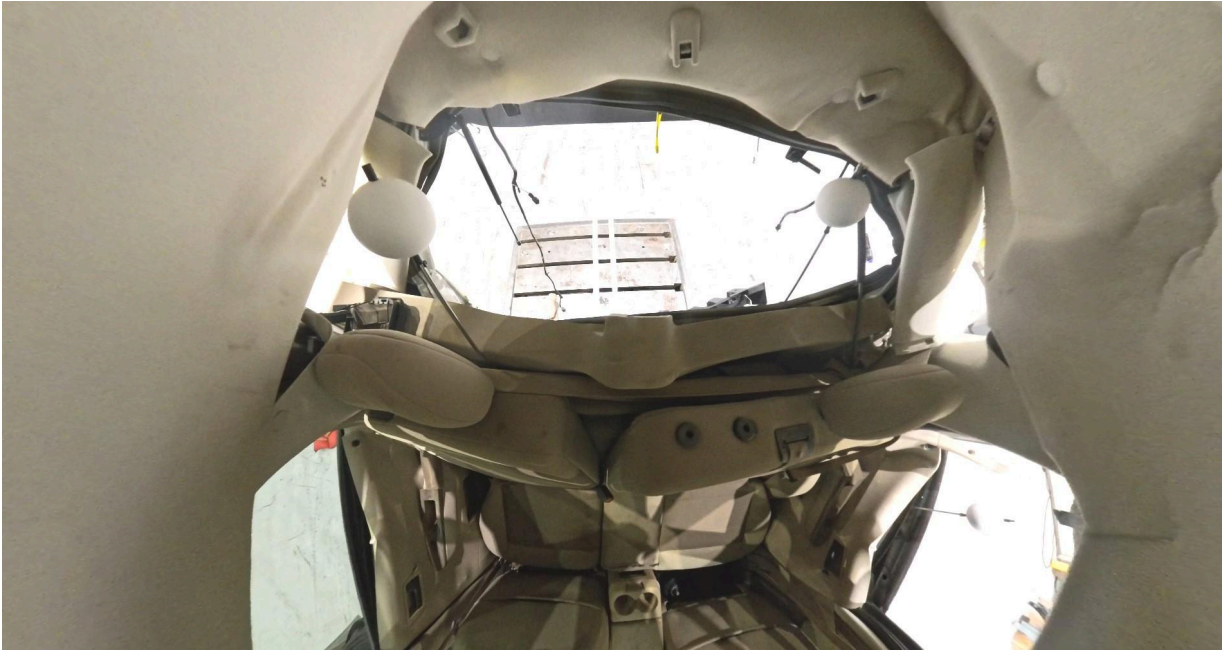
**Figure 68 through Figure 70** depicts still images extracted from a 360 video of the seatback area of the test Ford Escape. It can be seen that the seatback is displaced and distorted. In addition, these images show that the interior of the vehicle hatch made contact with the aft portion of the rear seatback.

**Figure 68:- Still image depicting the vehicle rear hatch and rear seatback.**

**Figure 69: Still image depicting the vehicle interior and rear seatback.**

**Figure 70: Still image depicting the vehicle rear hatch and rear seatback.**
